LIGHTNING EFFECTS RELATING TO AIRCRAFT
PART I - LIGHTNING EFFECTS ON AND ELECTROMAGNETIC
SHIELDING PROPERTIES OF BORON AND GRAPHITE
REINFORCED COMPOSITE MATERIALS

F.A. Fisher
High Voltage Laboratory
General Electric Company

Technical Report AFAL-TR-72-5

January 1972

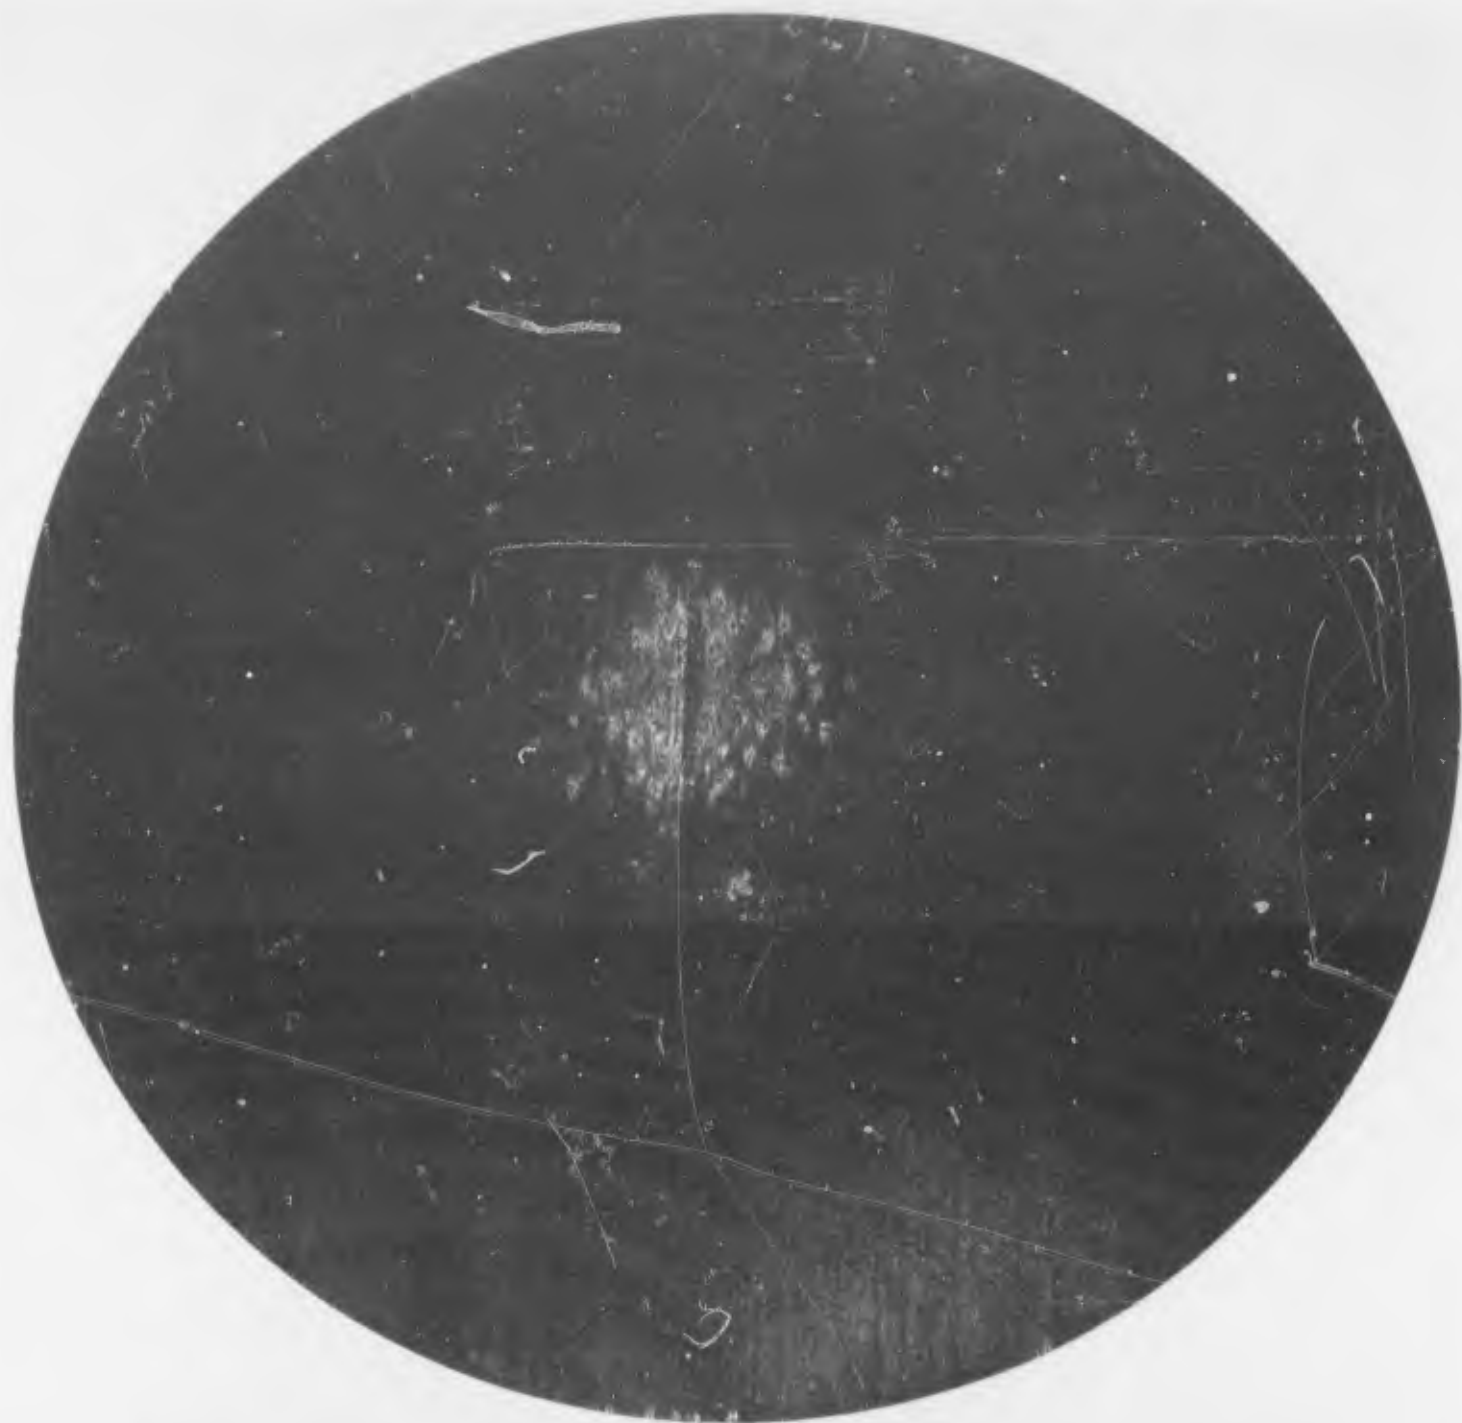
LS-70-5 (Front)
(61 kA)

FIGURE 70 - Appearance of Graphite Fiber/Epoxy Panel with Silver Paint Removed,
After Exposure to Simulated Lightning Discharge

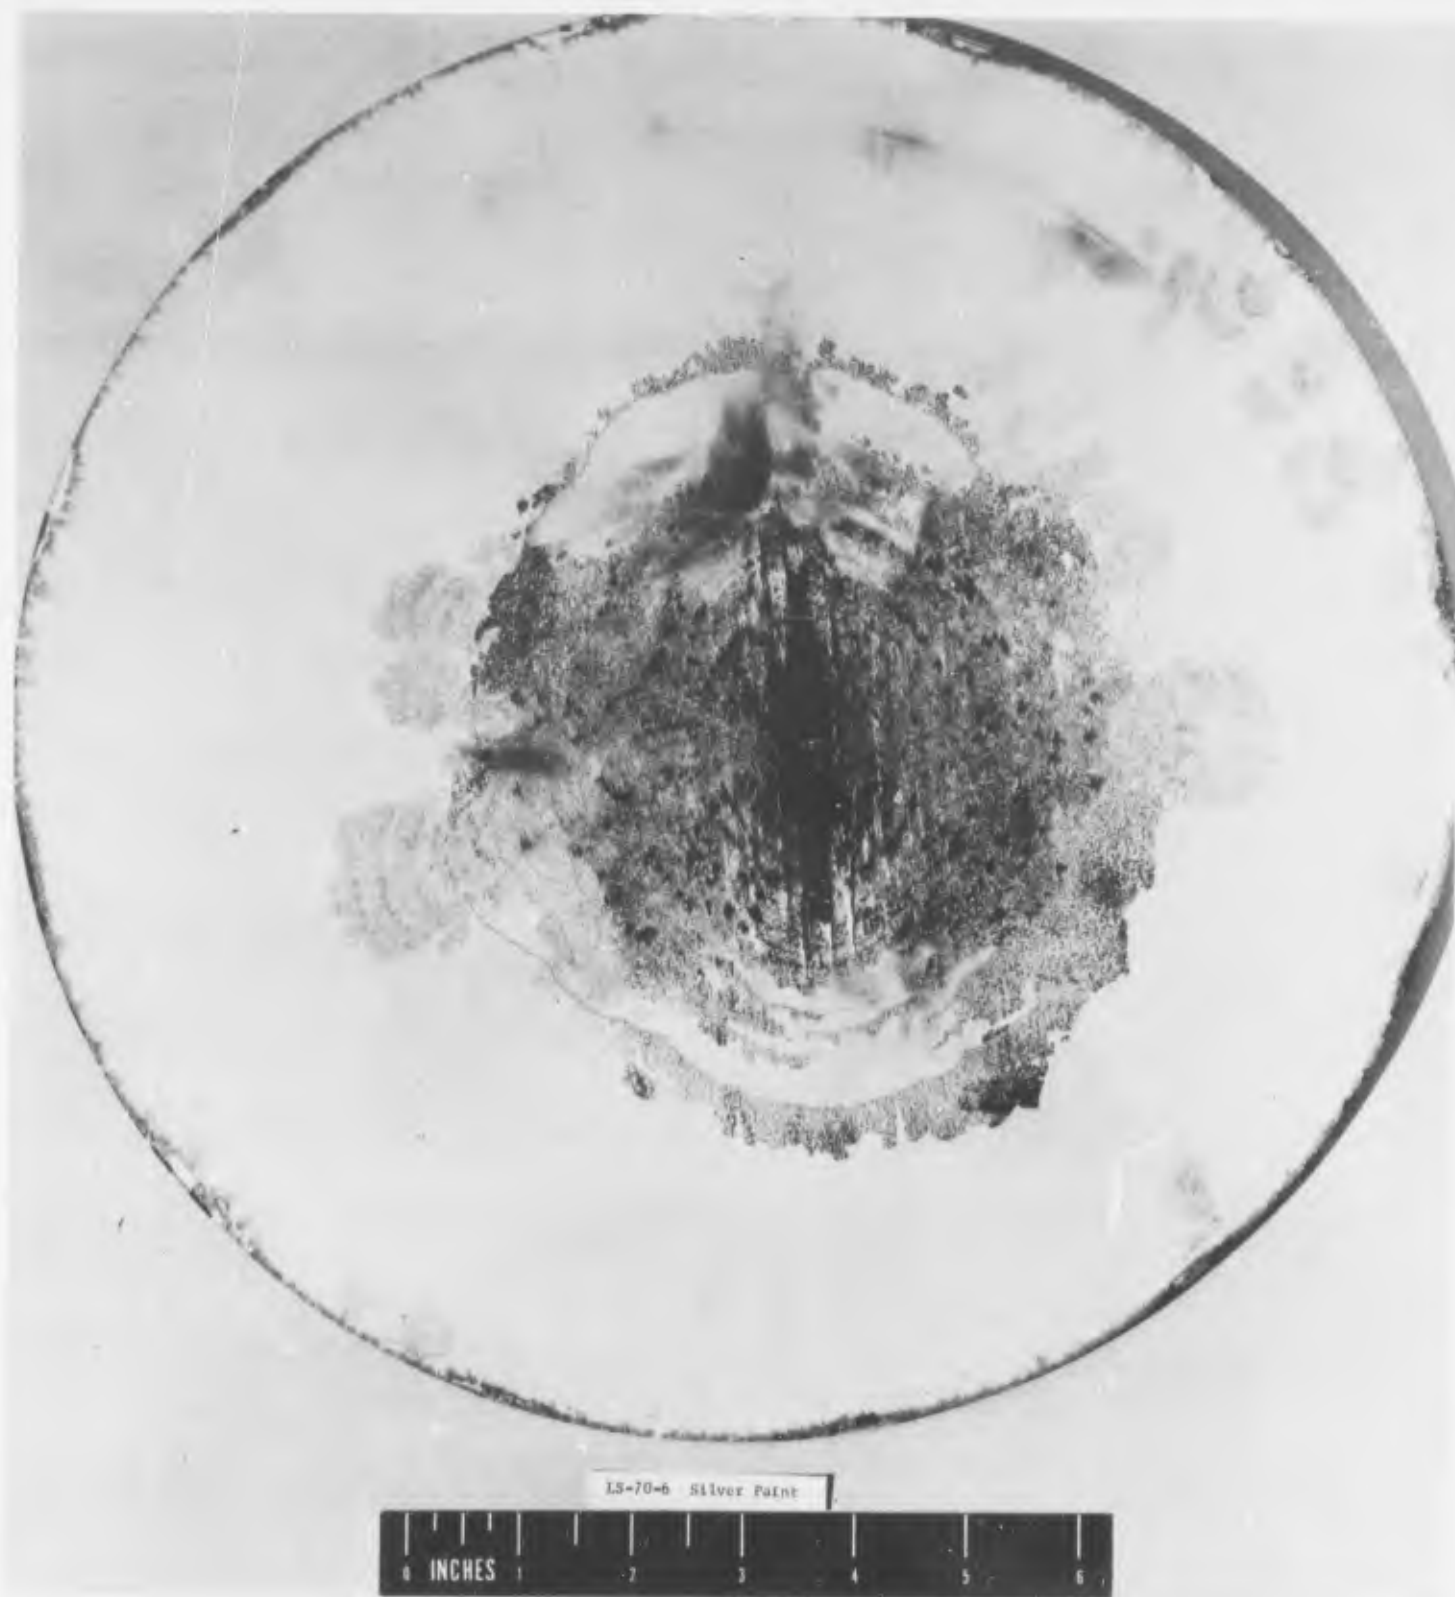
LS-70-6 (Front)
(103 kA)

FIGURE 71 - Damage to Graphite Fiber/Epoxy Panel Surface Coated with Silver Paint After Exposure to Simulated Lightning Discharge

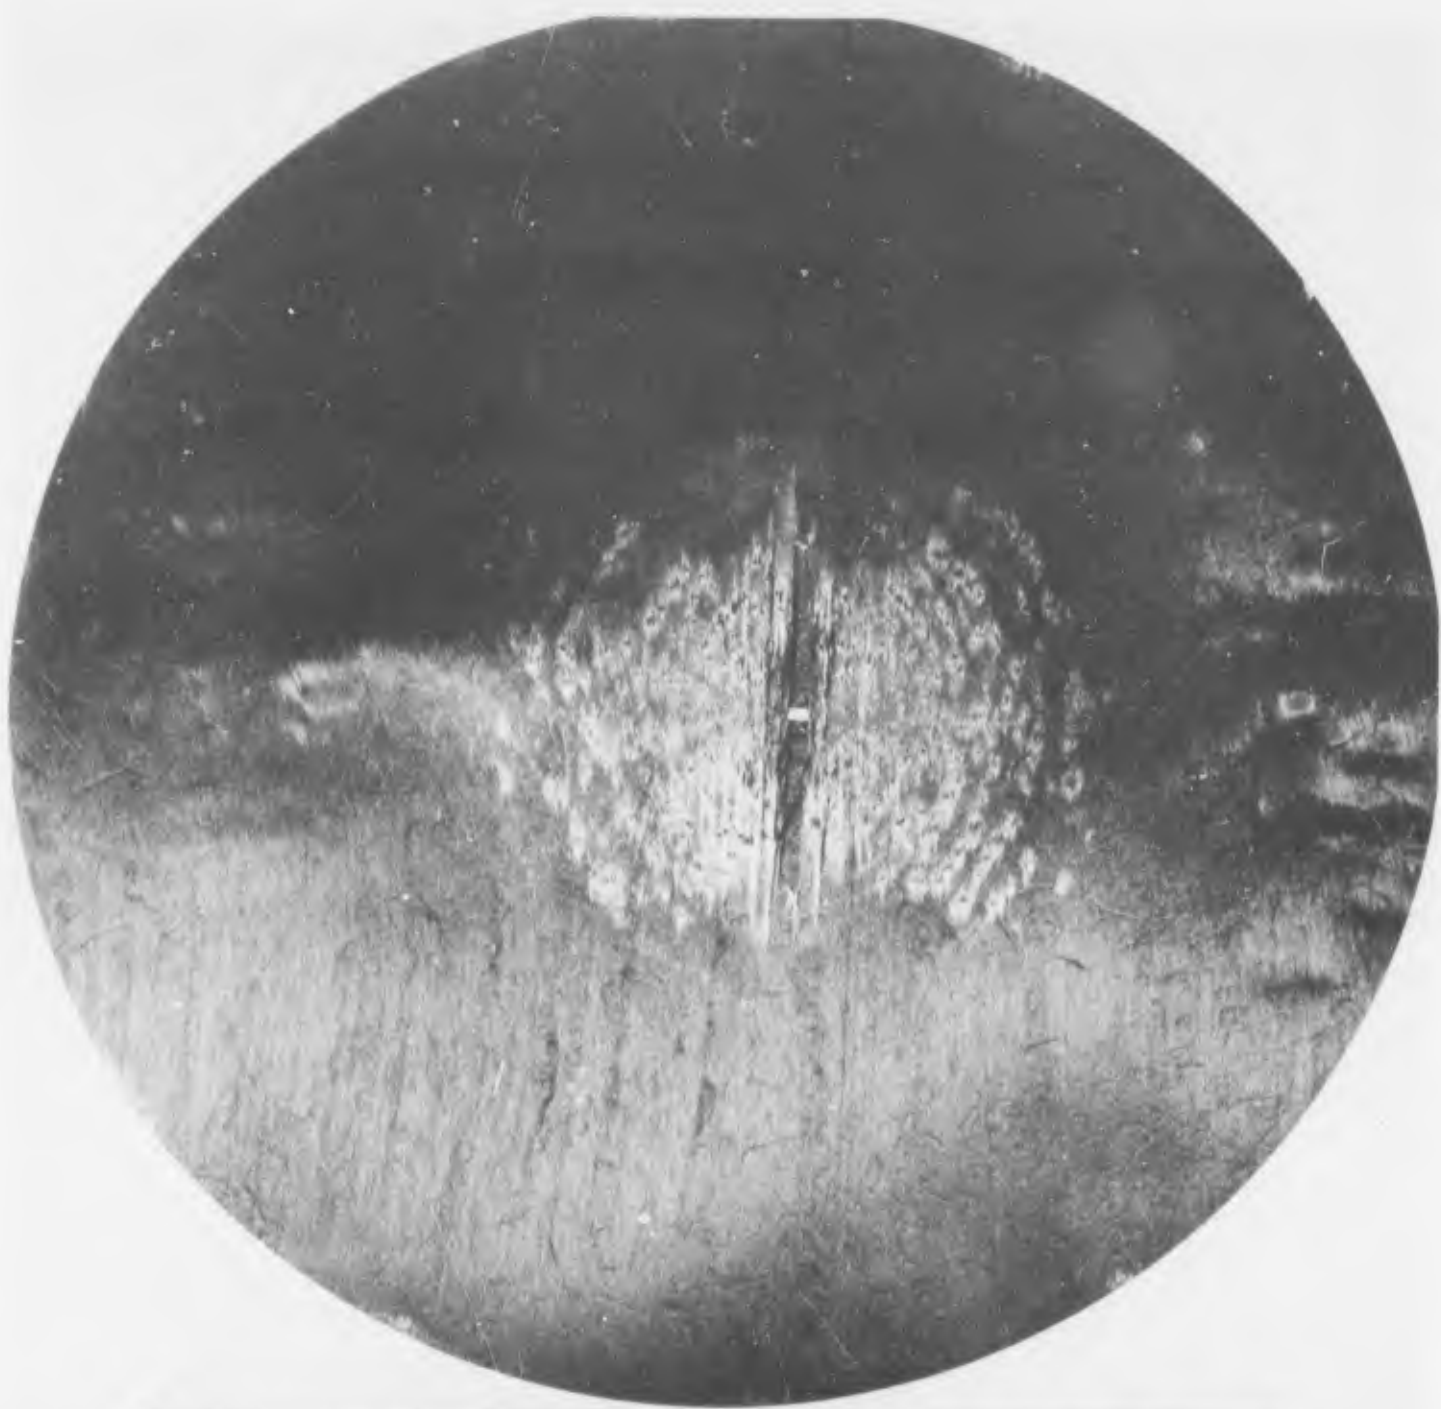
LS-70-6 (Front)
(103 kA)

FIGURE 72 - Appearance of Graphite Fiber/Epoxy Panel with Silver Paint Removed,
After Exposure to Simulated Lightning Discharge

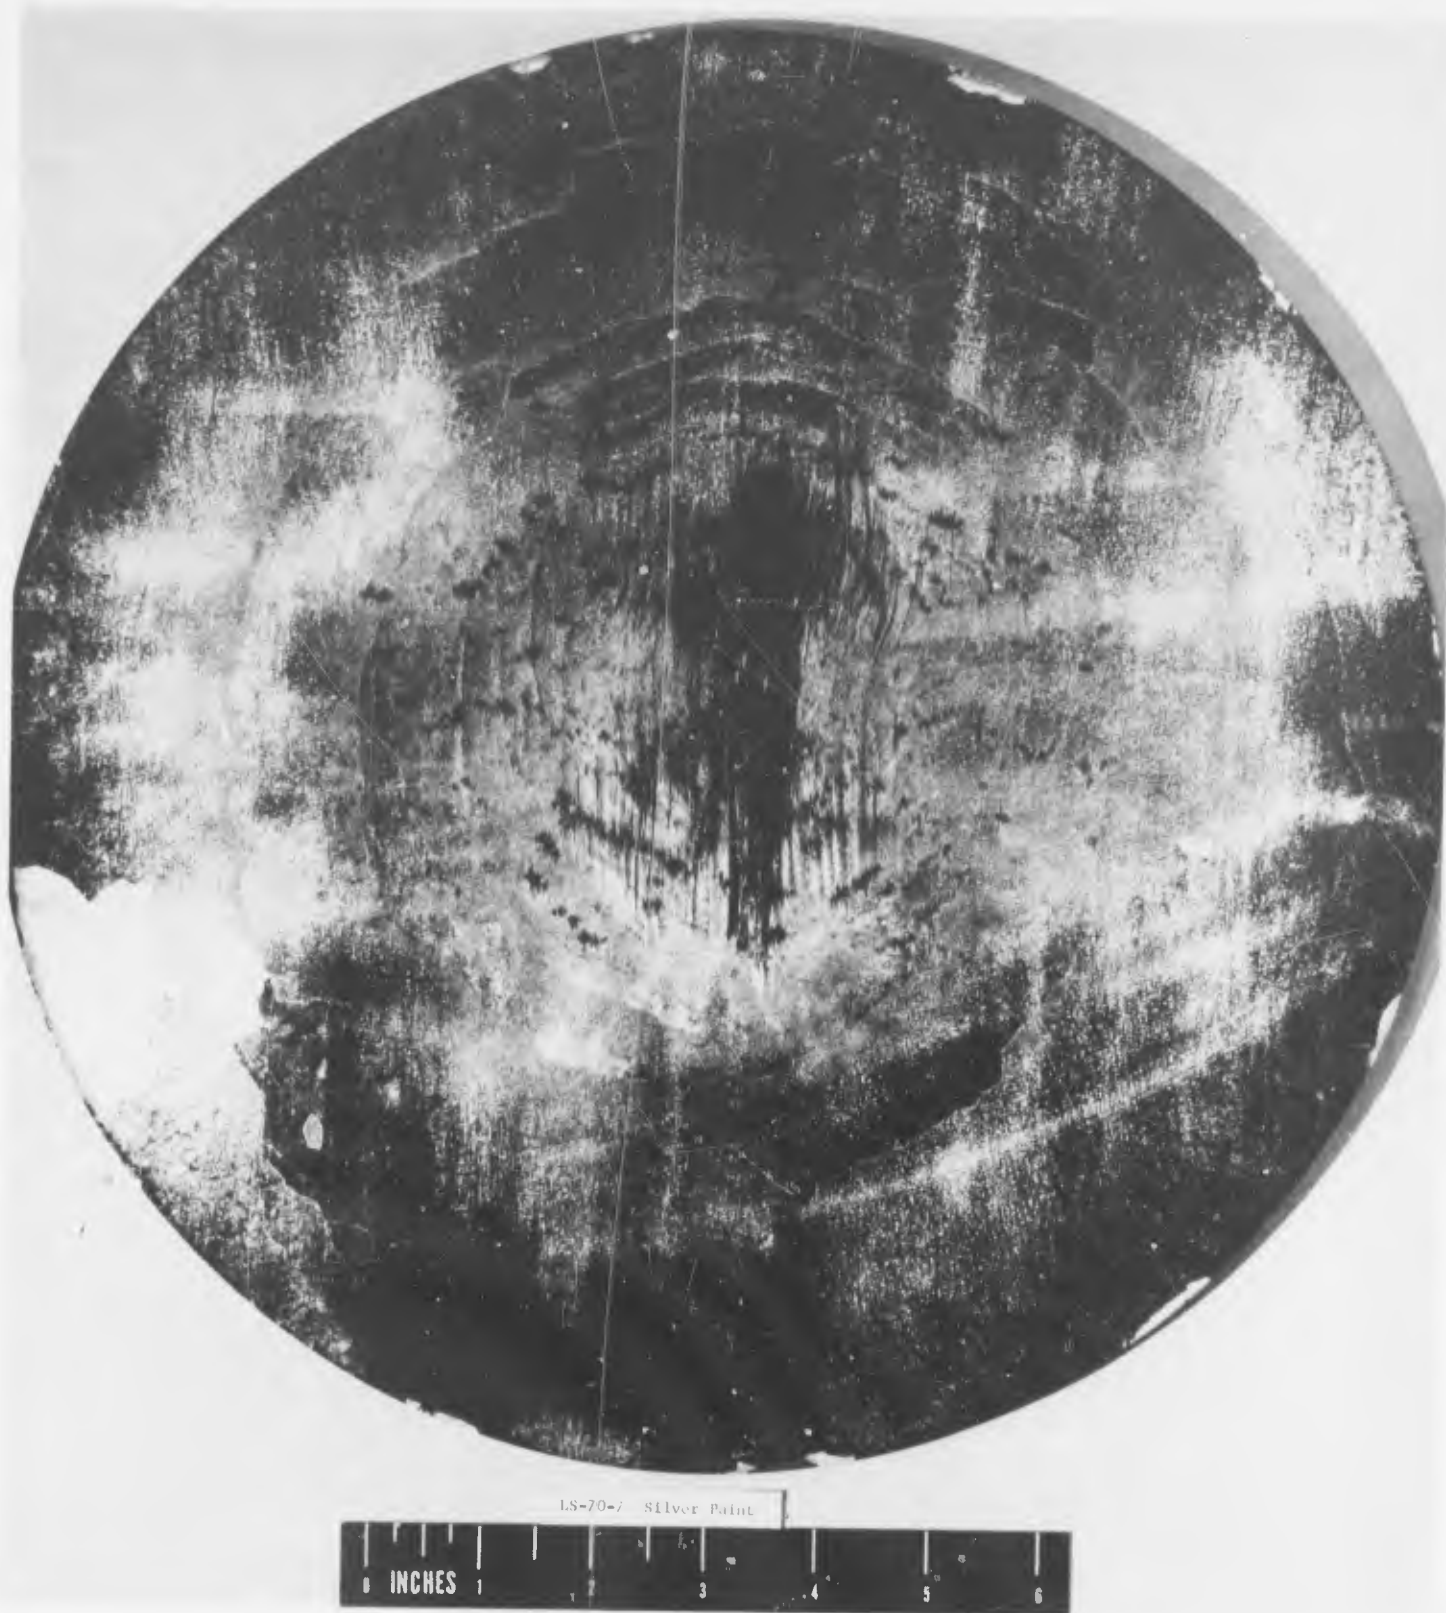
LS-70-7 (Front)
(185 kA)

FIGURE 73 - Damage to Graphite Fiber/Epoxy Panel Surface Coated with Silver Paint, After Exposure to Simulated Lightning Discharge

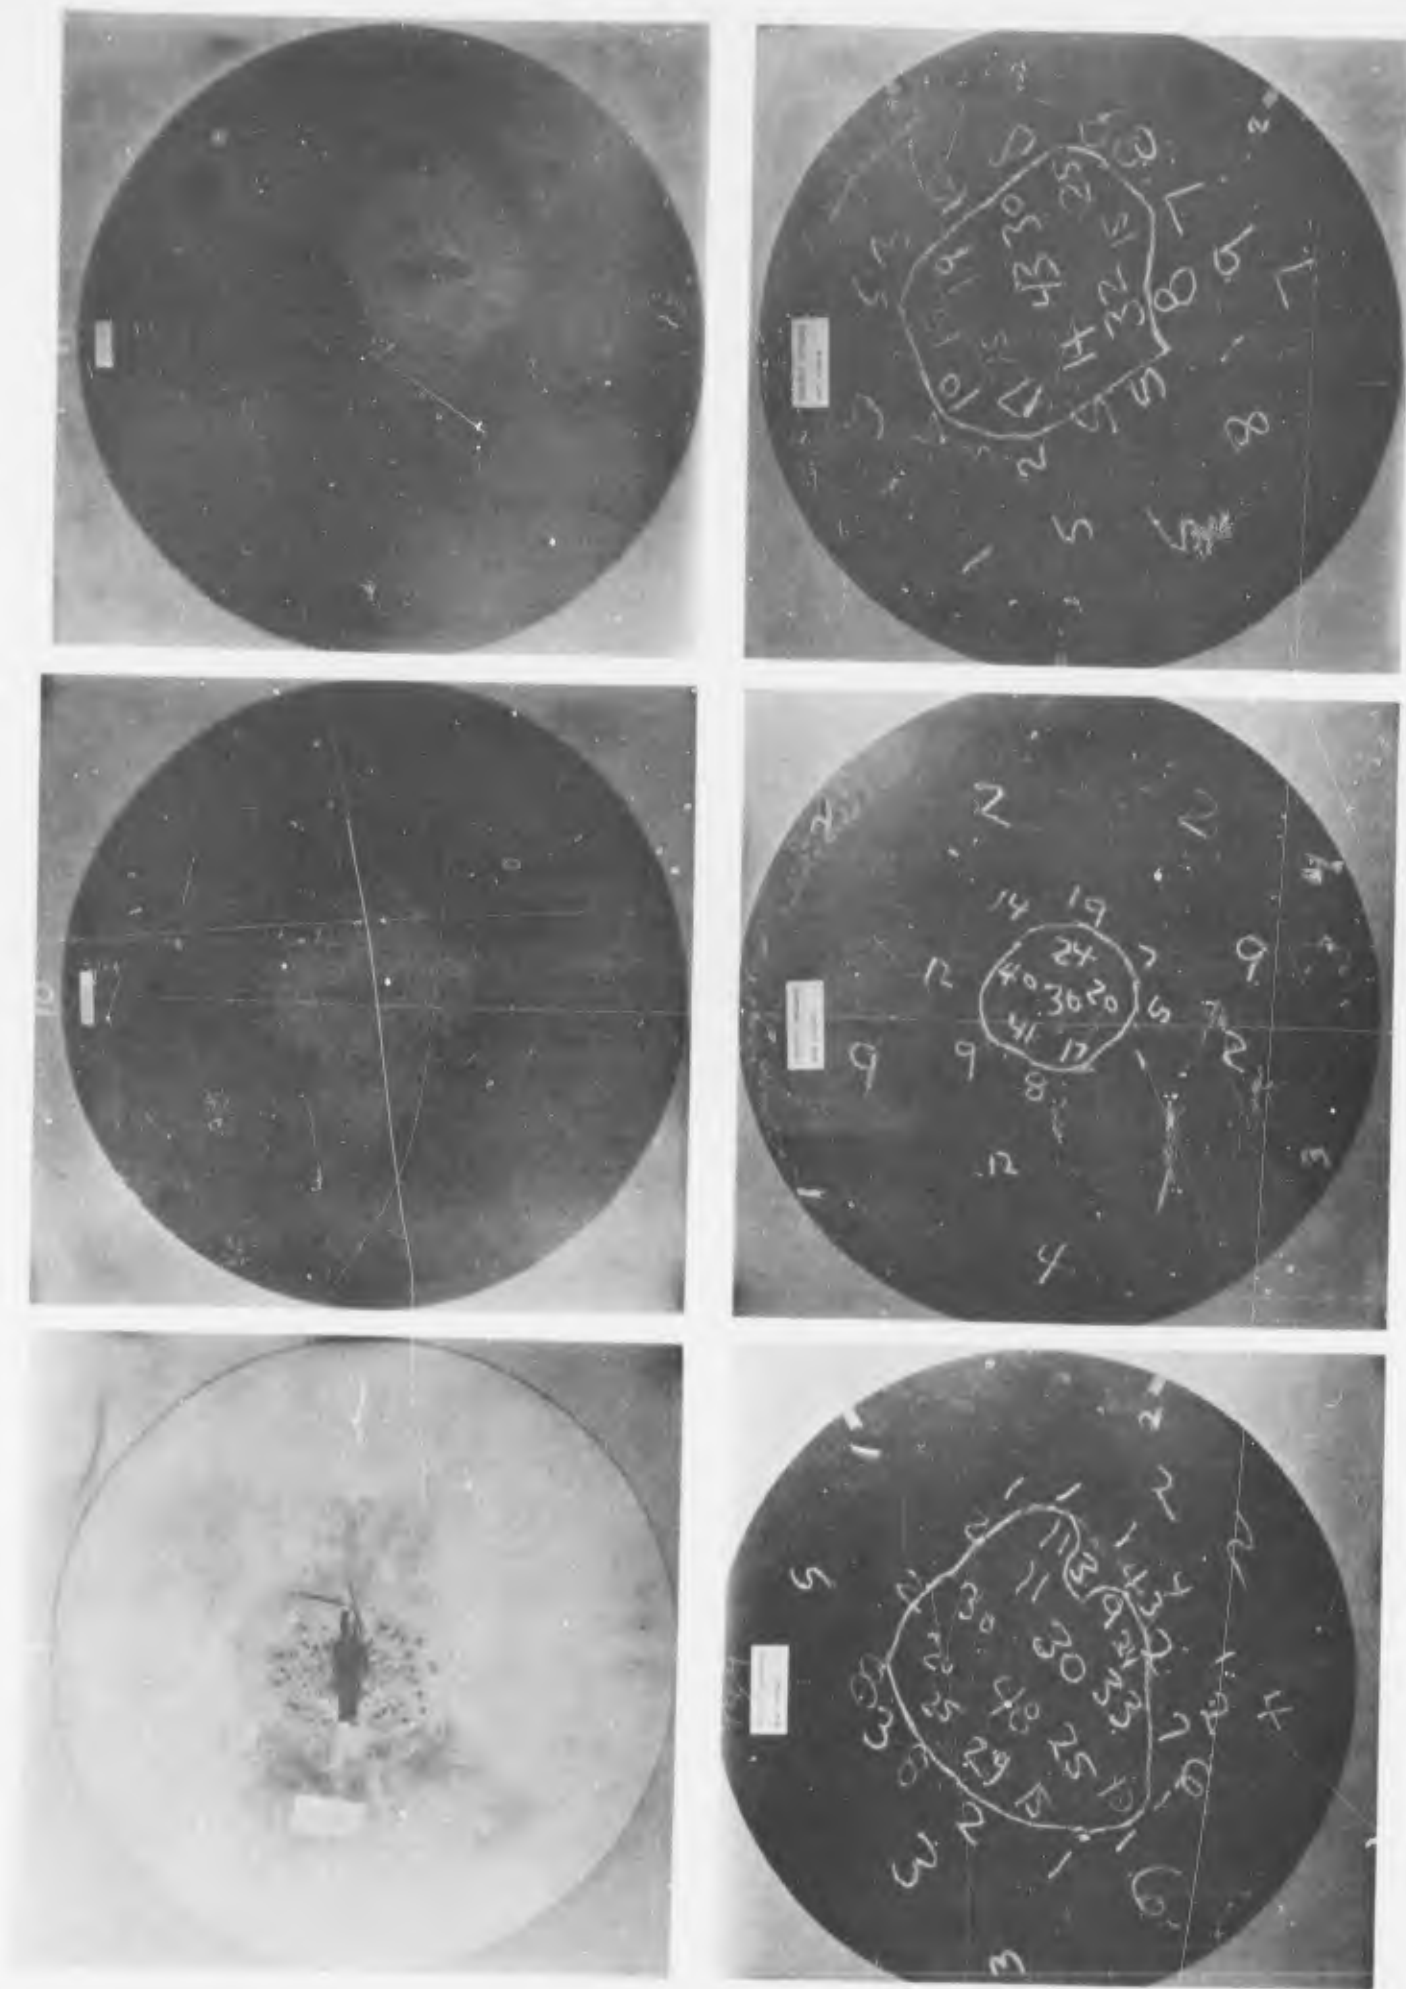
This was an uncoated, 0-90° layup panel of 0.120" thickness. It was tested at a current level intermediate between the 0.040" panels LS-70-2 (61 kA), LS-70-3 (57 kA), and panel LS-70-1 (85 kA). The area of disruption of the panel surface, or the discolored area, was about the same on

FIGURE 91 - Photographic Reductions of Panels LS-70-9, LS-70-10 and LS-70-11 Showing Both Sides After Strikes of Simulated Lightning

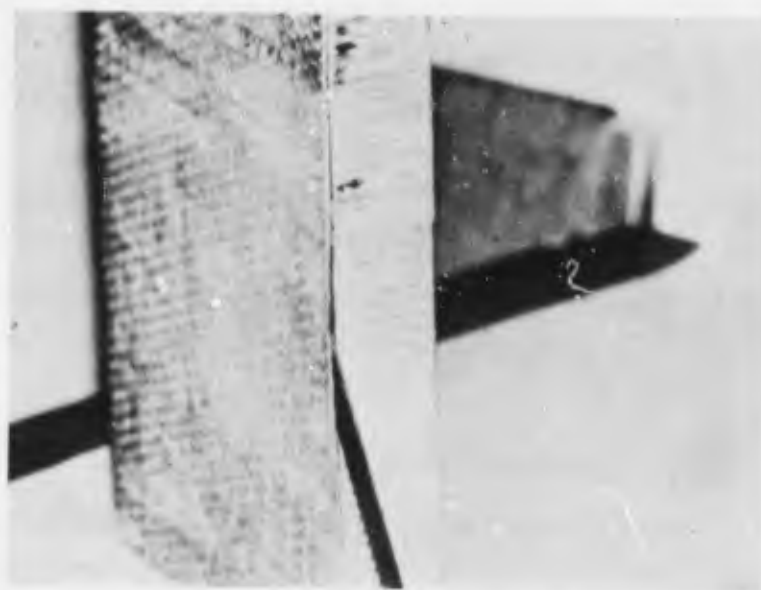
This panel received two tests, the first at 154 kA and the second at 203 kA. At the 154 kA level, there was apparently no damage to the panel except a slight discoloration of the surface. The amount of this discoloration was far less than was observed on the silver-paint coated samples at a much lower current level. At the second level of 203 kA, there was some pitting of the surface accompanied by a mechanical separation of the laminated surface from the honeycomb filler. Presumably the mechanical shock associated with the arc cracked the adhesive joining the panel to the honeycomb. Pictures of the resulting damage are shown on Figures 110-B and 110-C.

C. Sample BR-103-1 (Boeing Panel)
Showing Delamination caused by
203 kA Test Current
